Using the RQ-11 Raven-A and the T-Hawk for Oversight Inspections of Surface Coal Mines in West Virginia

Presented by
Natalie L. Carter
U.S. Office of Surface Mining
Beckley, West Virginia

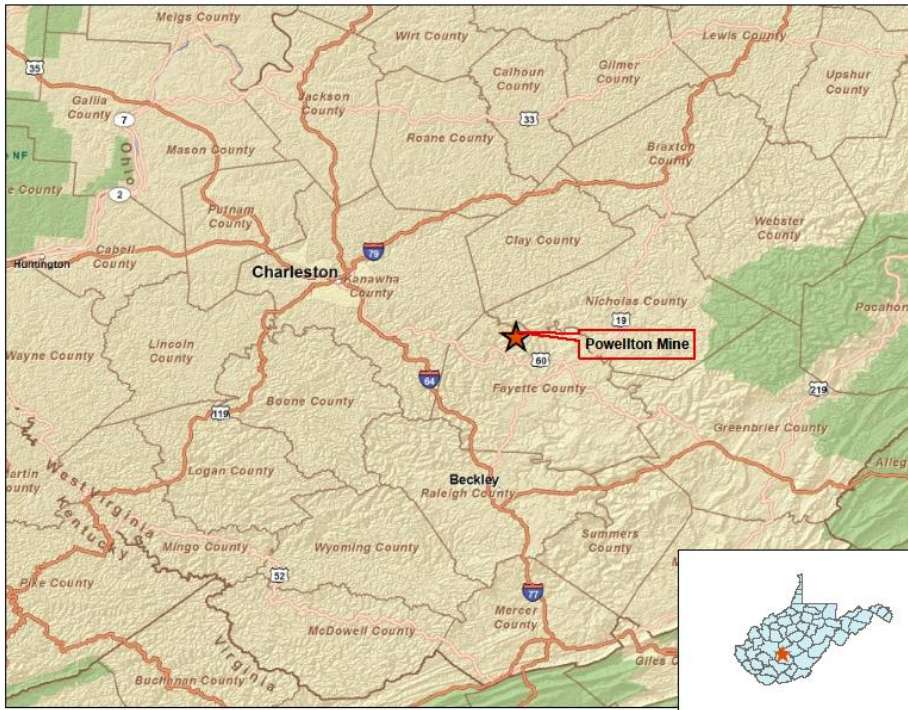
- The Bridge Fork West Surface Mine
- Fayette Co., WV
- Issued June 21, 2004
- 463.8 acre Contour strip mine
- Site mostly reclaimed

- Site selection
- Must be a mine site
- Multiple on the ground features
- Underground mine fire

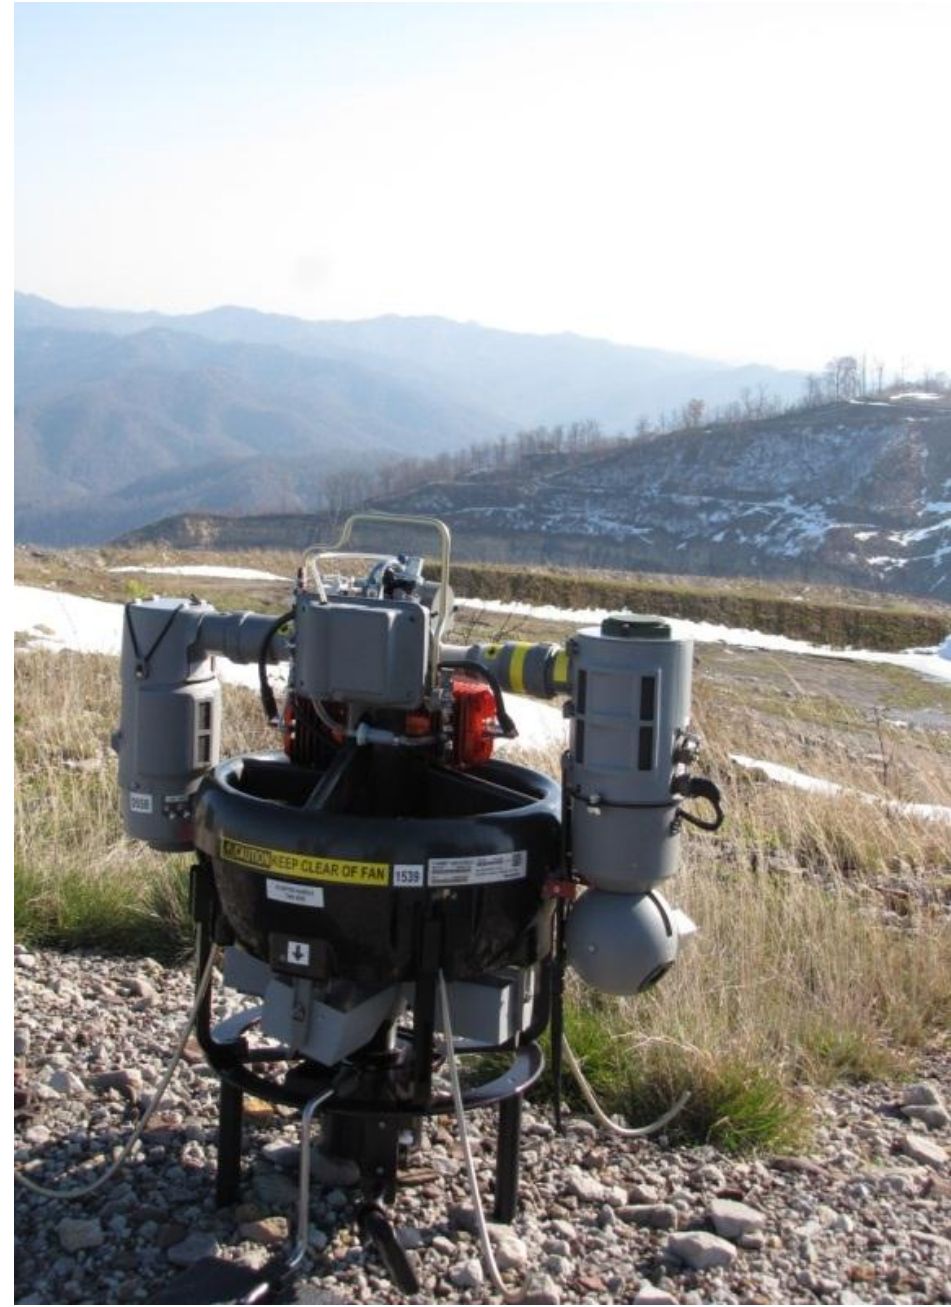
The RQ-16A T-Hawk

- Micro Air Vehicle (MAV) with ducted fan
- Vertical Take Off and Landing
- Weight: 20 lbs
- Capable of up to 81 mph speed
- Flight time: 40 minutes
- One person operation
- Fuel : Aviation fuel
- Cost \$500,000

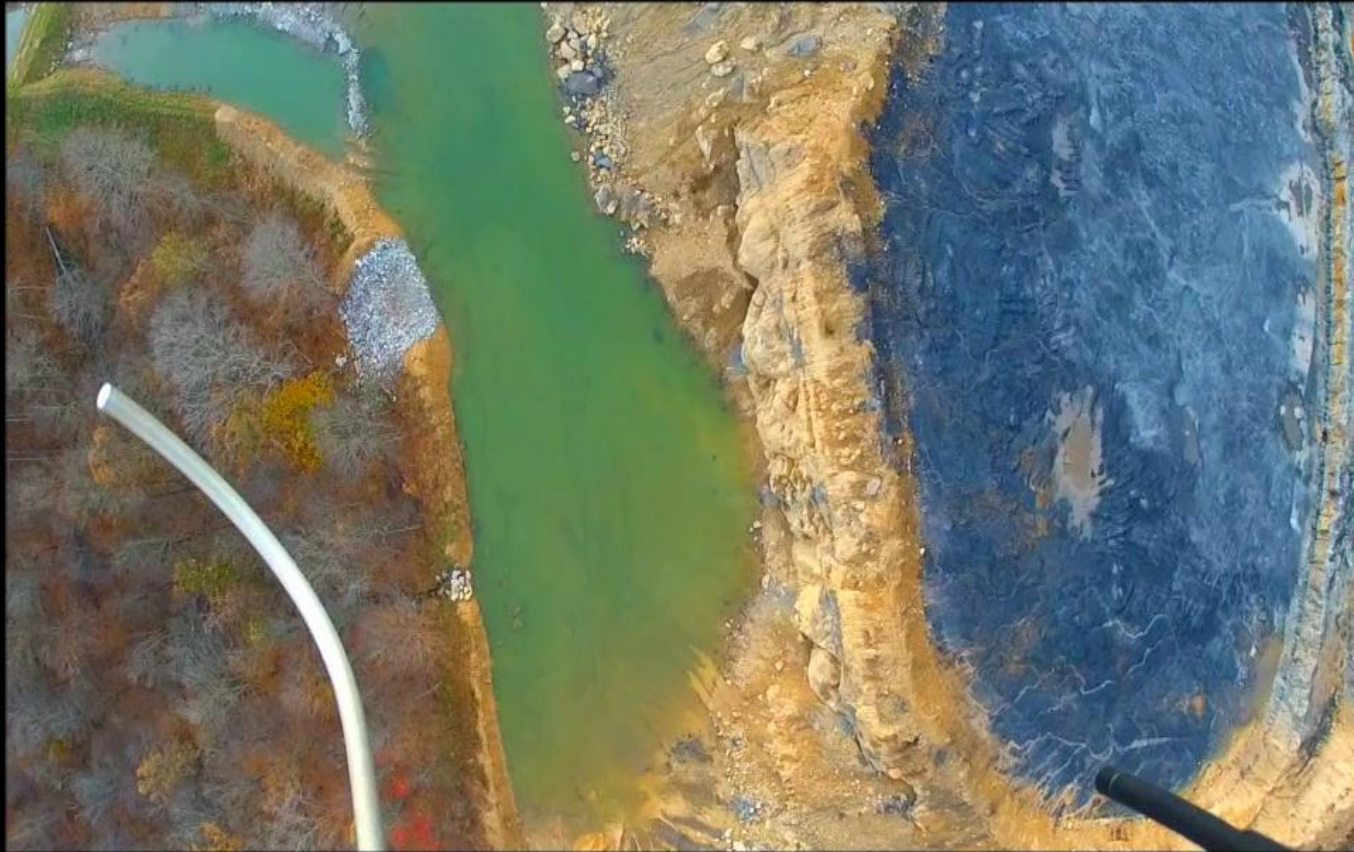
- Helps identify potential problem areas

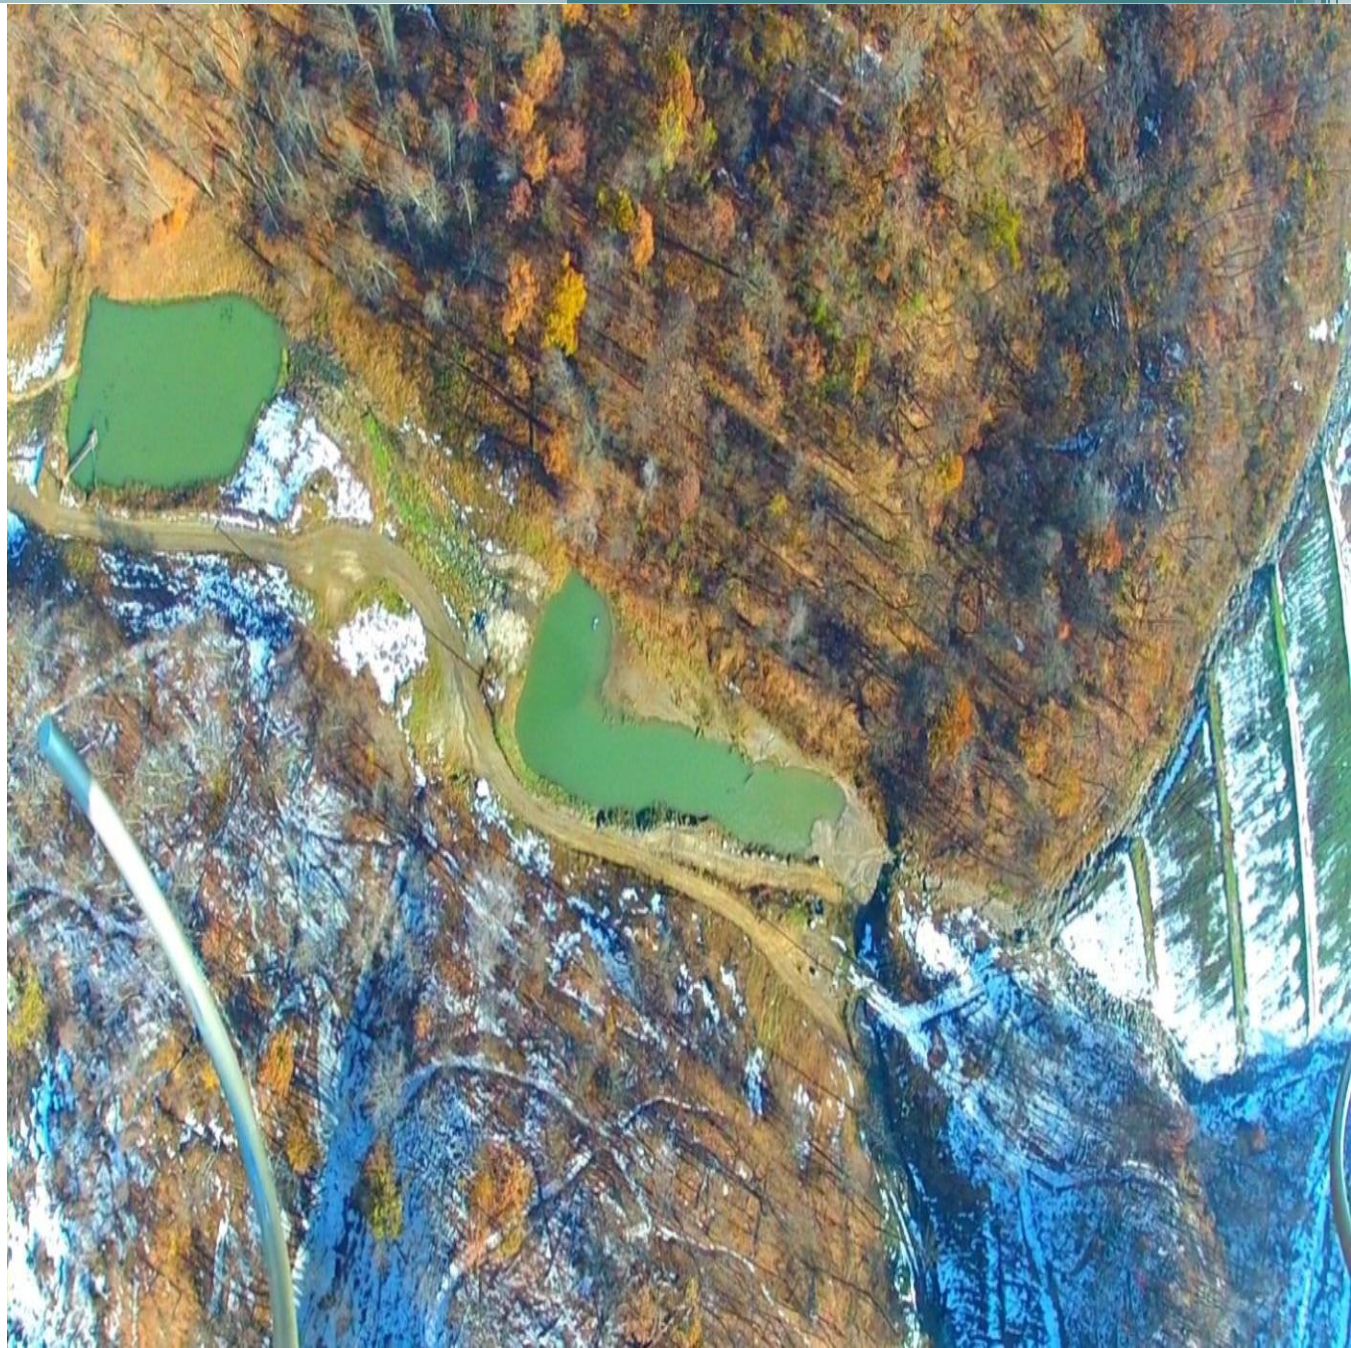
Scale

- **Pond 1A-**
Spillway bottom
 - 45' measured
 - 42.96' certified
 - 43' calculated
- **Top**
 - 65' measured
 - 66.10' certified
 - 69' calculated

- **Pond 1B-**
Spillway bottom
 - 42' measured
 - 44.6' certified
 - 43' calculated
- **Top**
 - 65' measured
 - 67.5' certified
 - 65' calculated
